No Fishing at Kalakaua Center: How the Leaks Were Plugged

by Vi Bashian Cooper

That's exactly what the development manager, the Honolulu firm of Graham Murata Russell, faced during the transformation, now in progress, of the long-vacant Mitsukoshi Building into Kalakaua Center.

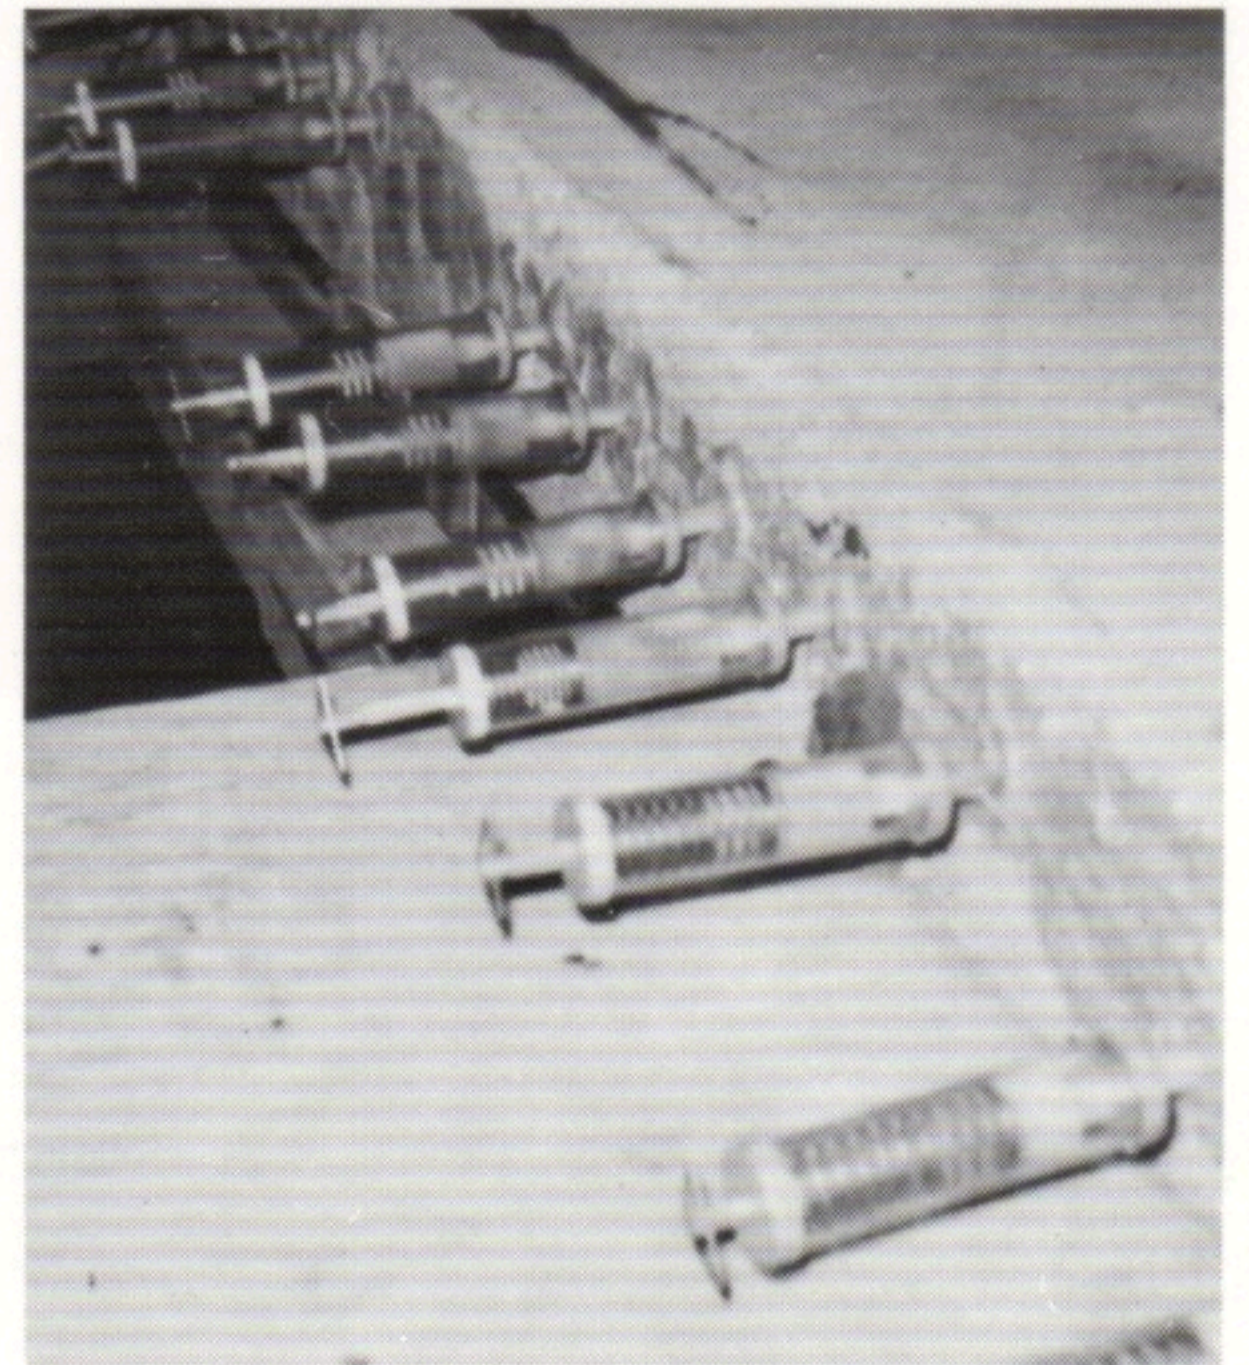
Extremely long horizontal cracks in this slab were repaired by injecting epoxy through capsules mounted on the surface. Later a new top coat of concrete was applied.

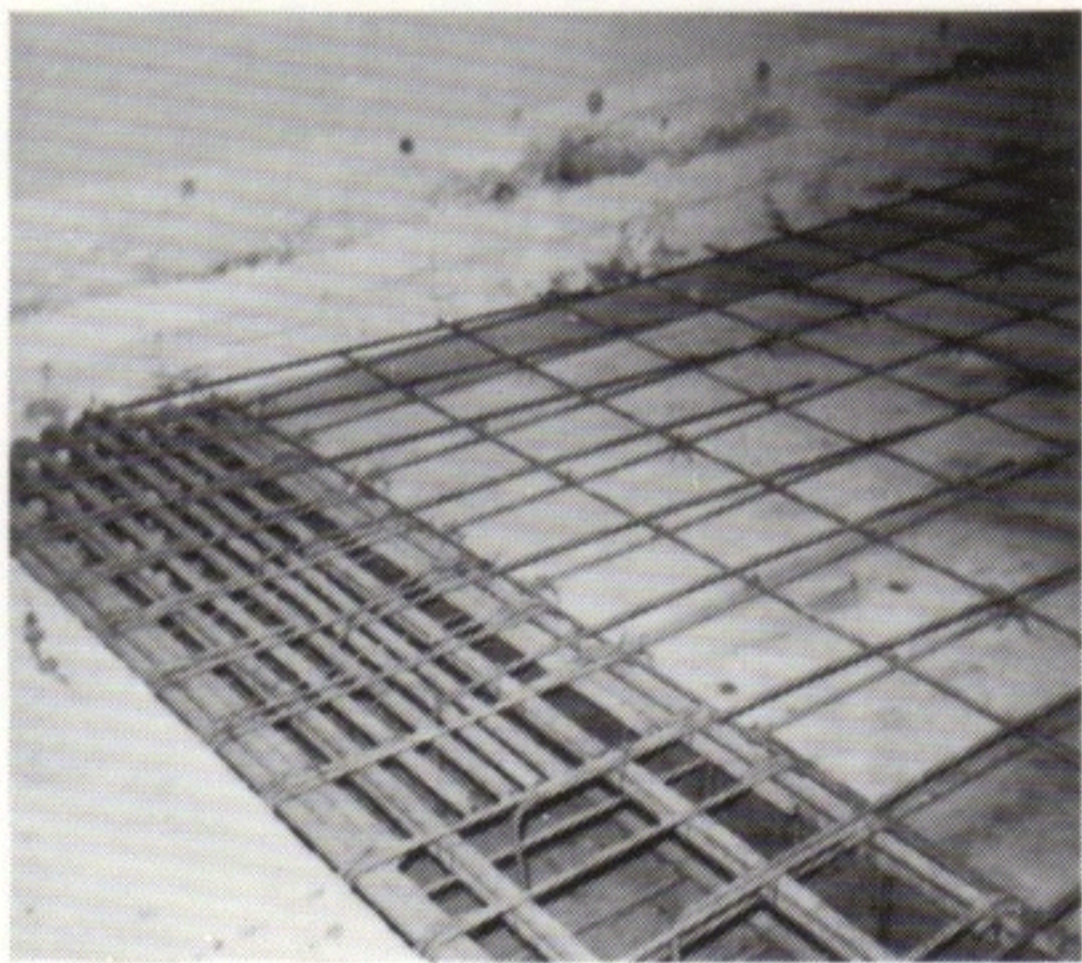
RCM's crews tore out a concrete-topped metal deck, reformed it and installed new reinforcing steel and concrete to repair severe spalling.

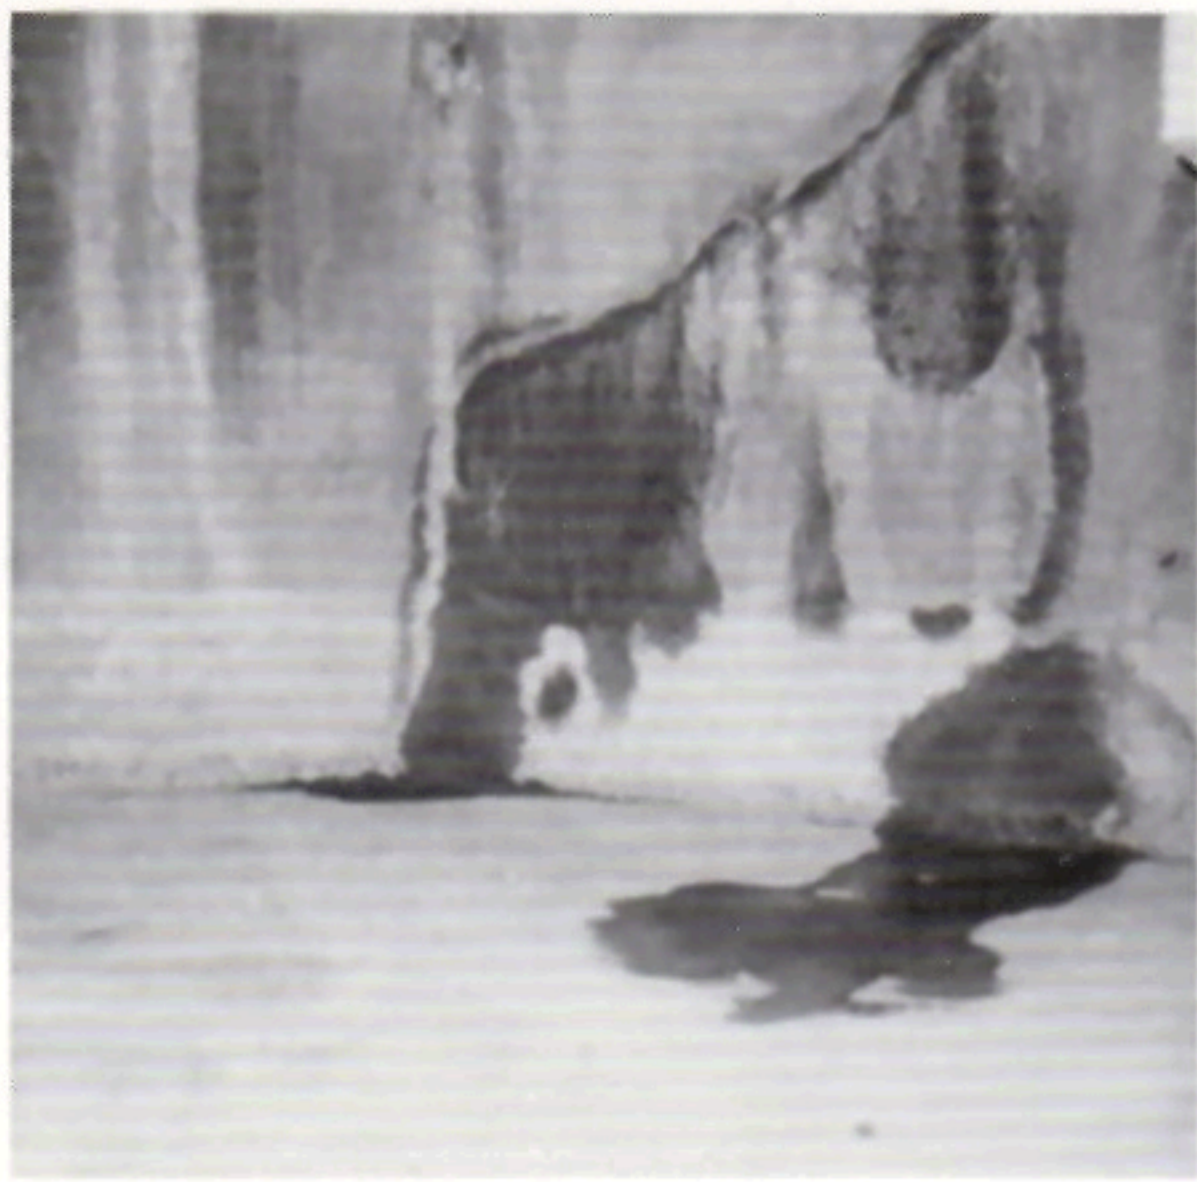
Just one of hundreds of typical wall leaks in Kalakaua Center's underground parking garage.

For the cracks in the walls, RCM used a low-pressure epoxy system to inject a low-viscosity resin capable of penetrating cracks as small as .0007 inch. The wall was then painted white.

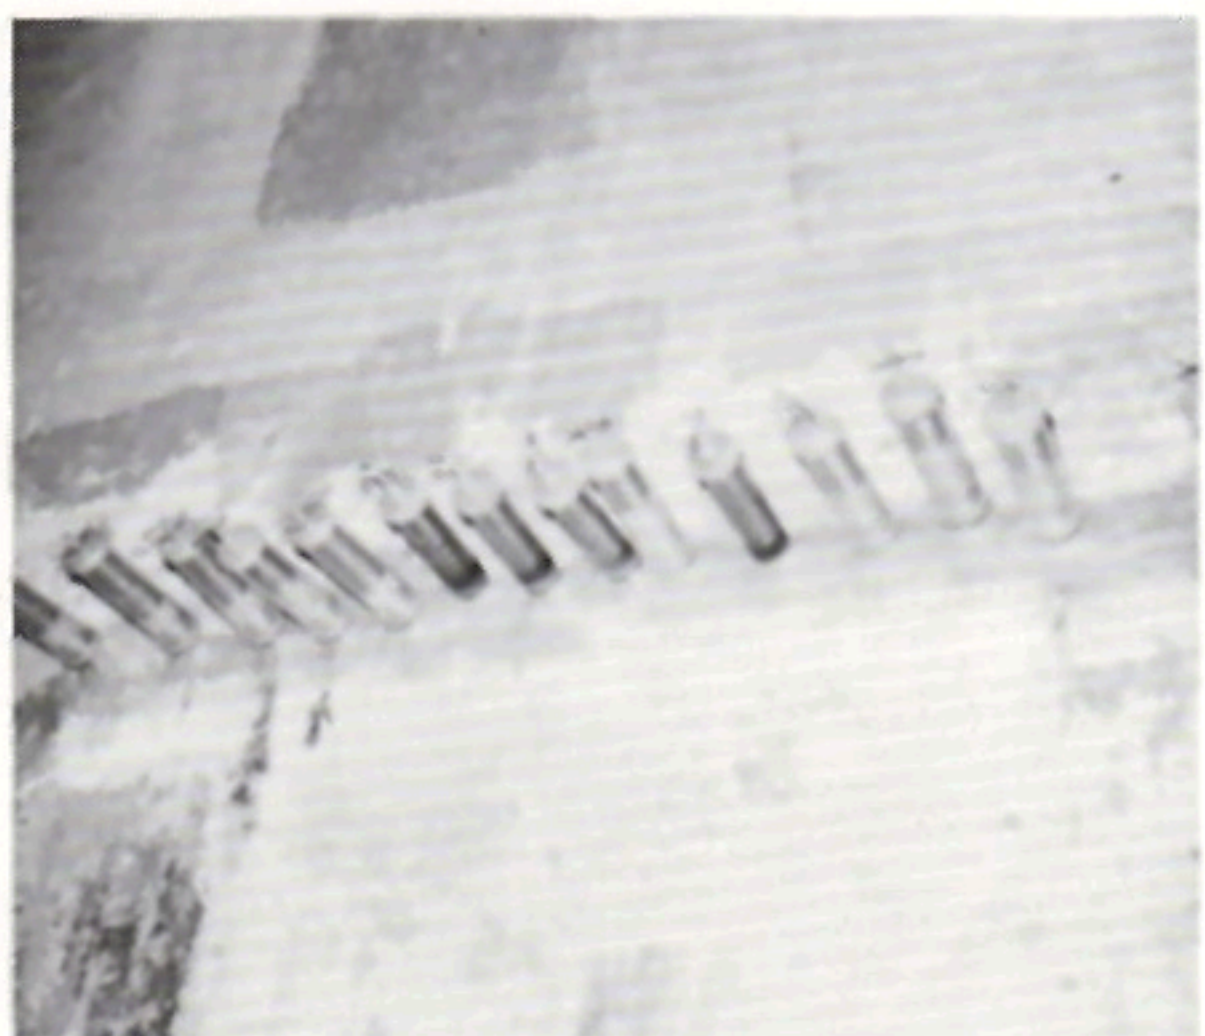
Leaks at an intersection of the perimeter wall pour were epoxy-injected, then recoated and painted.

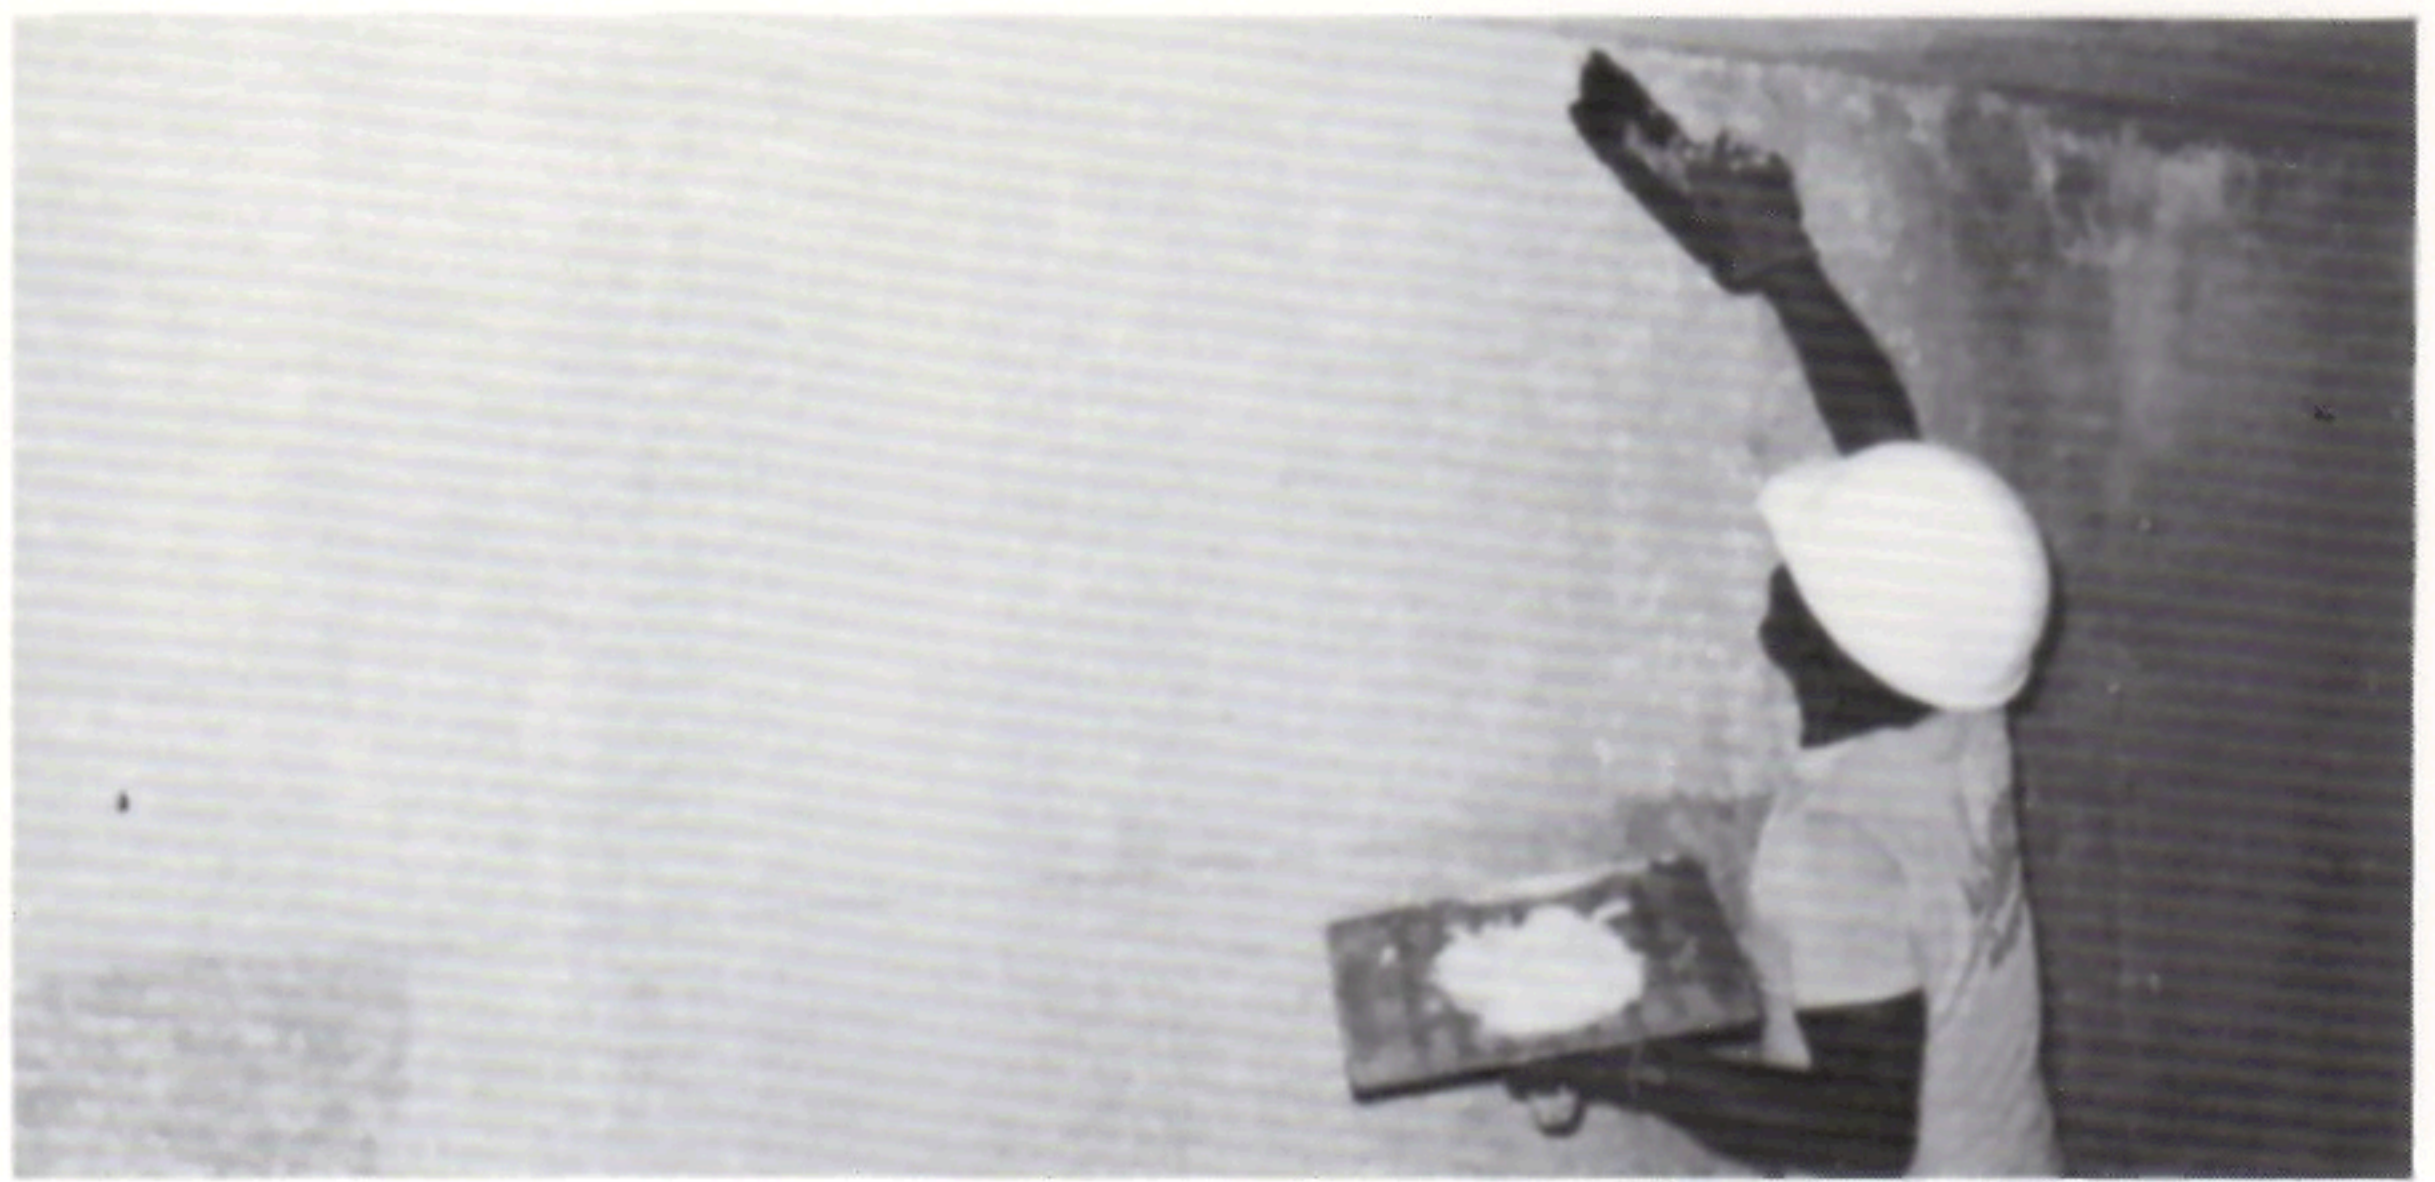
Repairing wall joints required a multi-step process of chipping away damaged concrete, using a cementitious hydraulic filler as a water plug, applying several different types of epoxy mortars and coatings, then repainting the area.

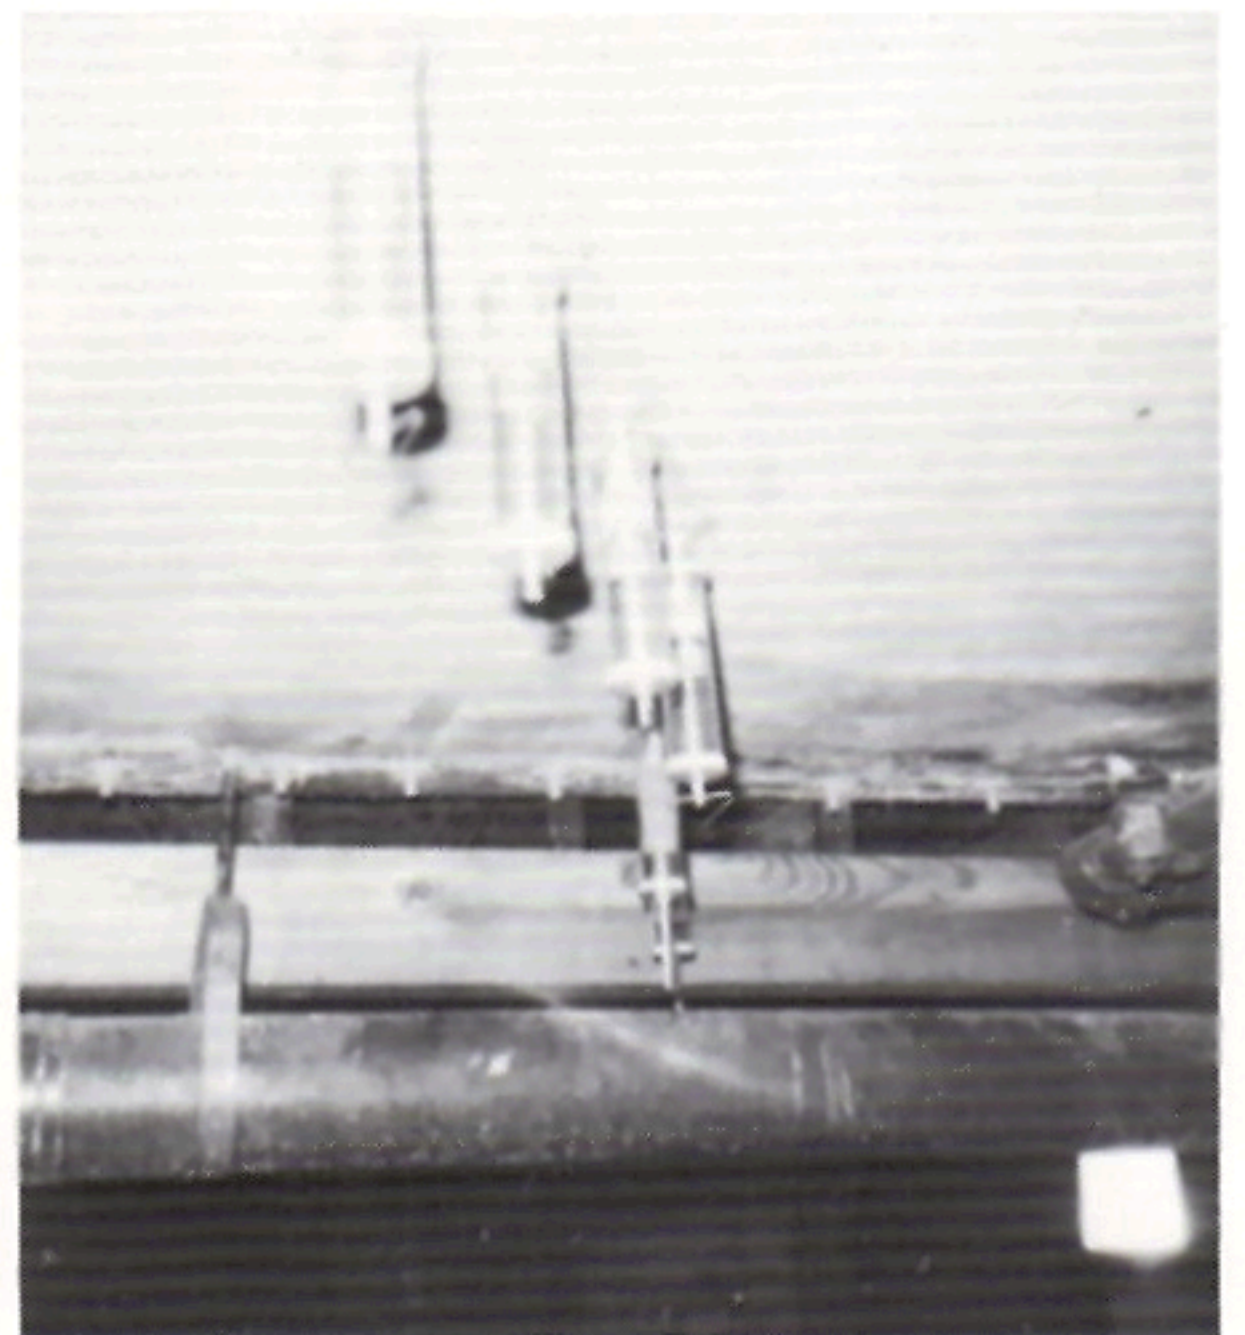
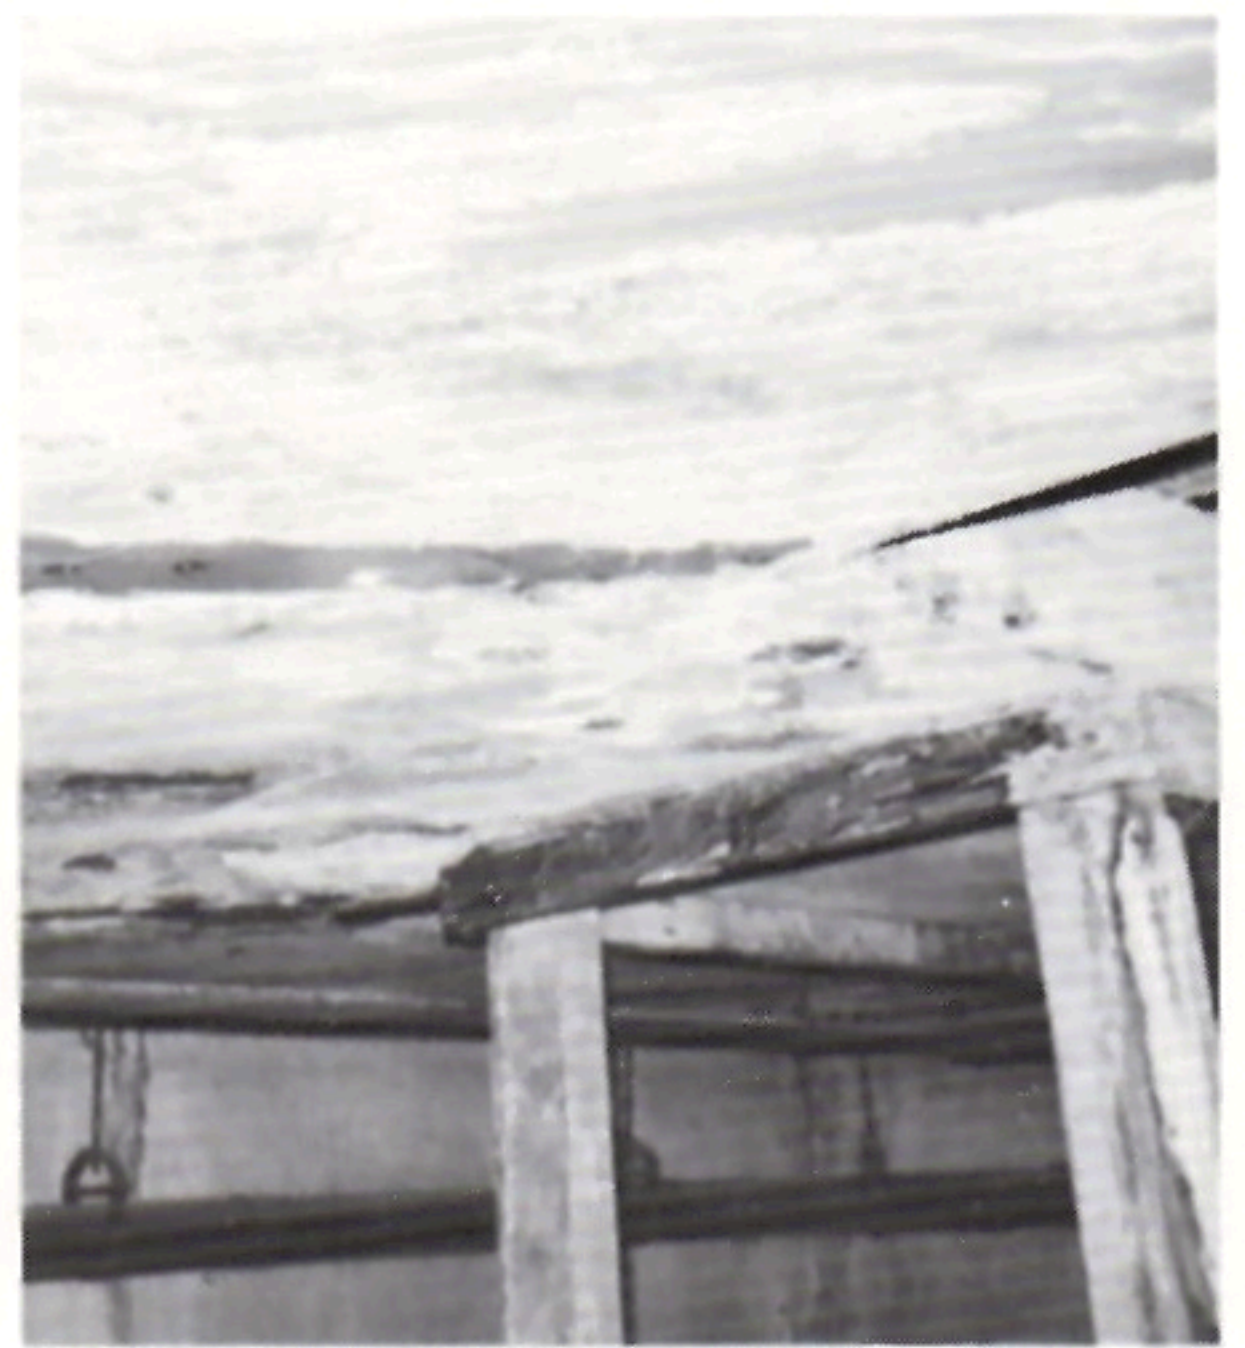
Above, epoxy injection around an earth-filled cavity. Below, the underside of an earth-filled cavity, looking up at a gunite slab.

"We were surprised when we injected over 30 lbs of epoxy resin into the slab to fill these cracks," Malmgren recalled. "Then to strengthen the old structure, we built up several walls of CMU along the parking stall lines and sprayed a 6-inch gunite reinforced slab below the old supported slab and on top of the new CMU walls."

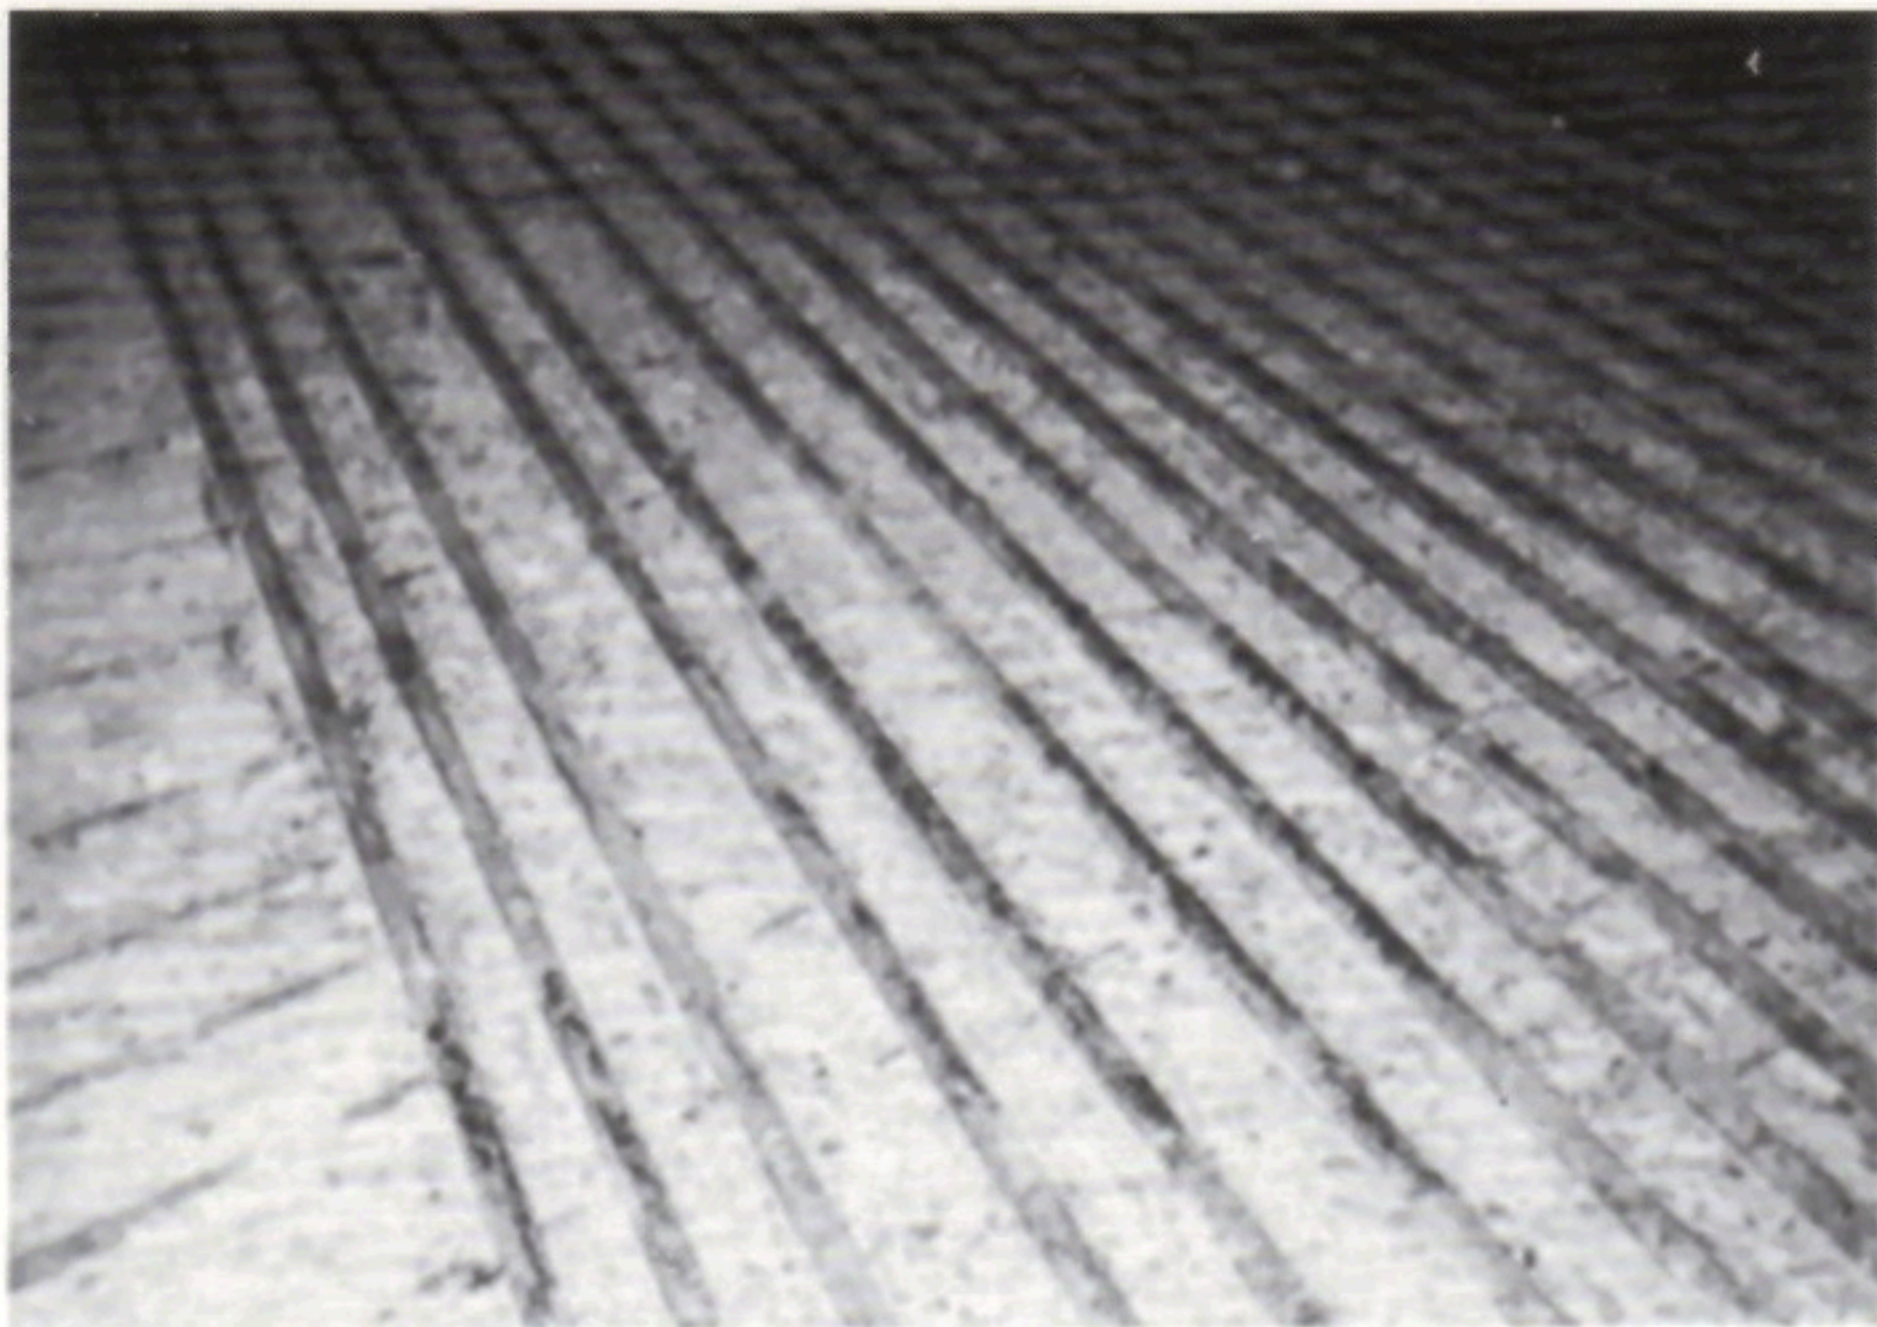
Several large areas near five vent shafts were chipped away, rusting reinforcing bars cleaned and new bonding materials applied before new concrete topping was poured.

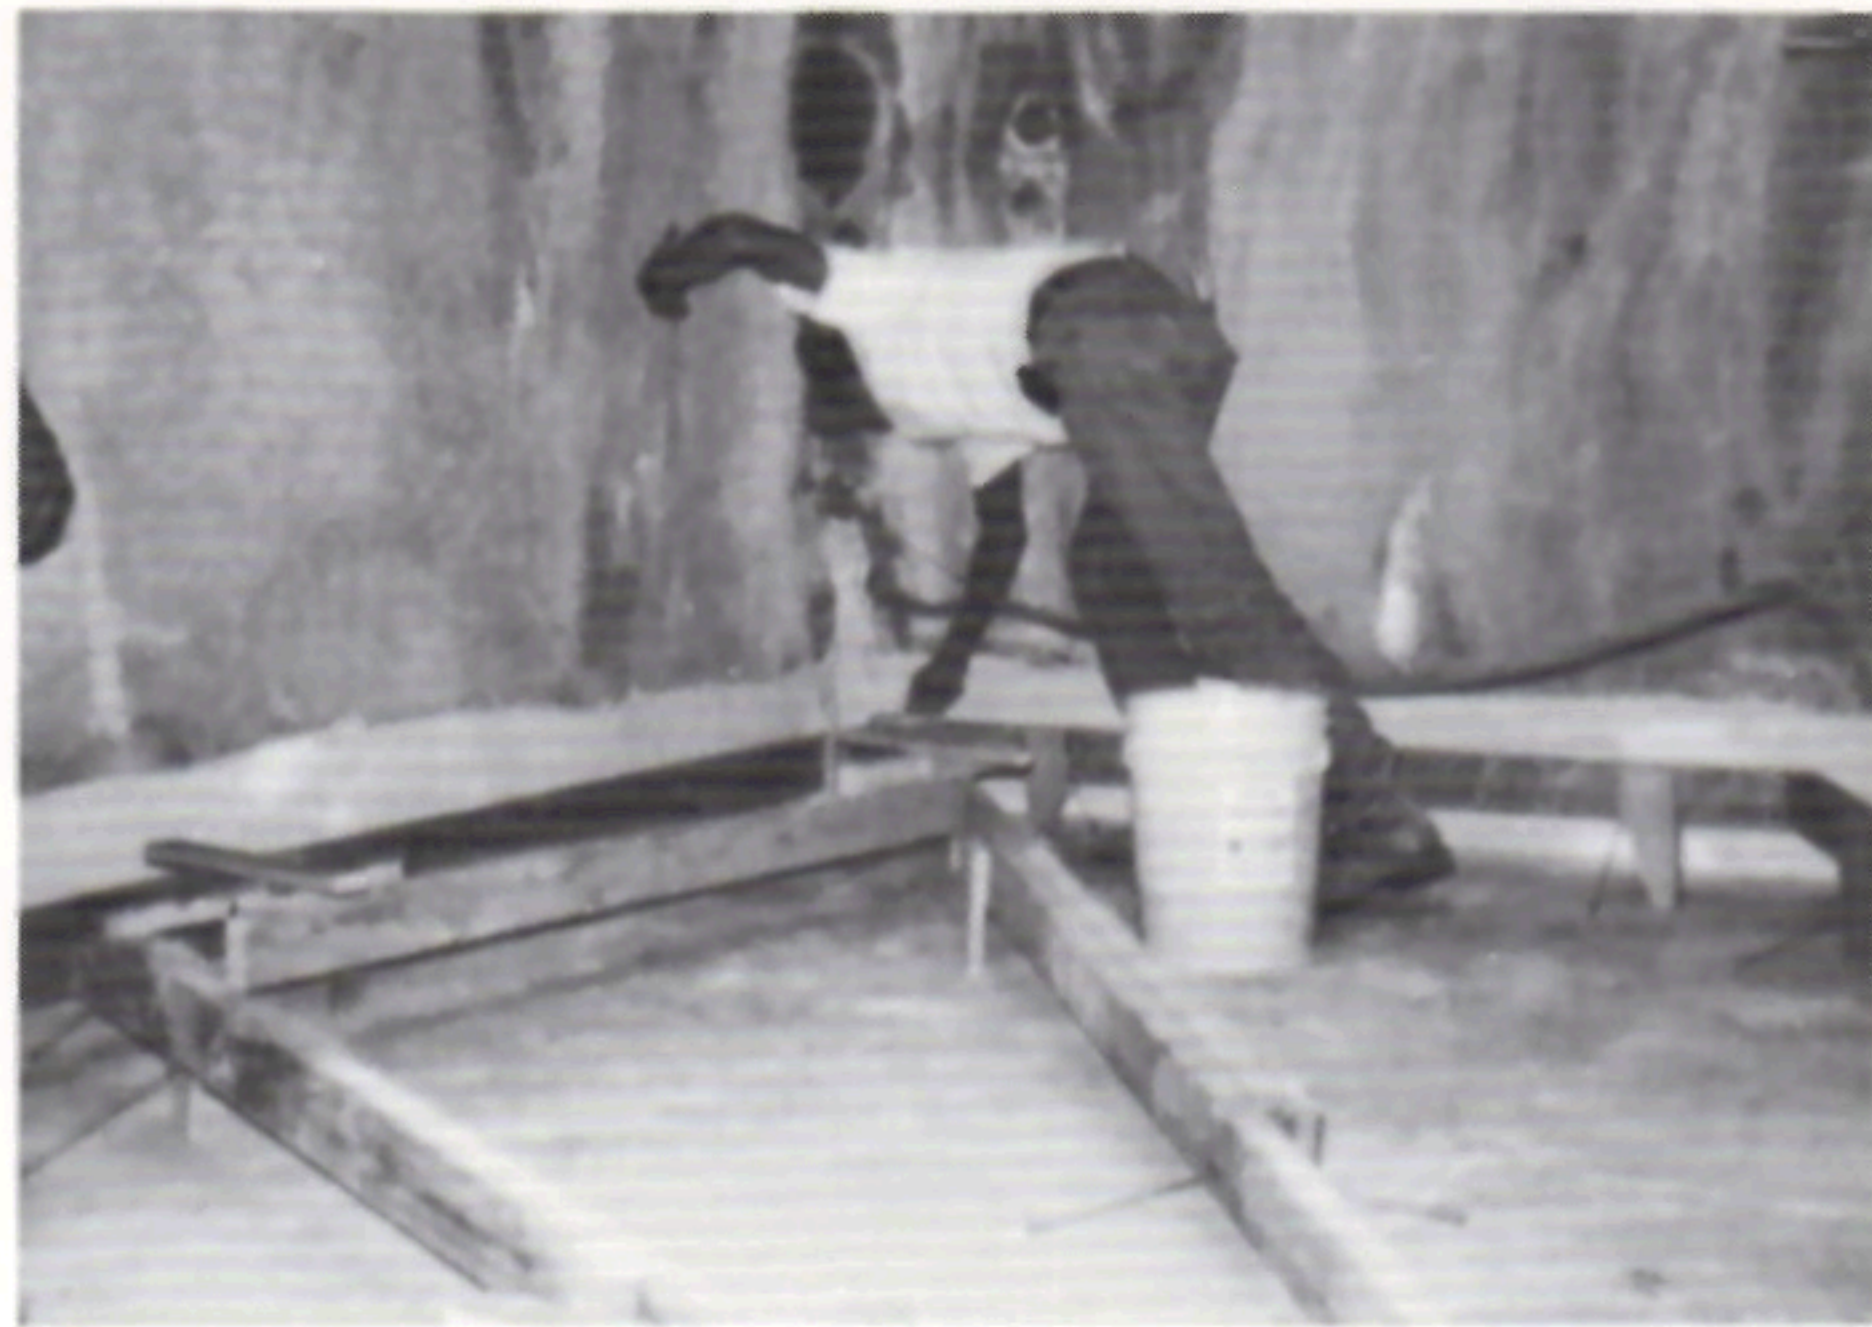
Water-stained vent shafts required patching, injection, recoating and painting. This multi-step process required an elastomeric membrane-coated concrete deck sloped to a new sump pit.

"Given the amount of water infiltration we encountered in the shafts," Malmgren said, "we decided to give the water a new path to escape by drilling 1-inch holes in the wall and installing tubing to act as temporary drains.

"We then used the hydraulic cement approach and epoxy coatings and injection, combined with an elastomeric membrane to dry up the shaft. The temporary drain tubing turned out to be a very effective method of drying surfaces, so we used it in the other wall areas as well."

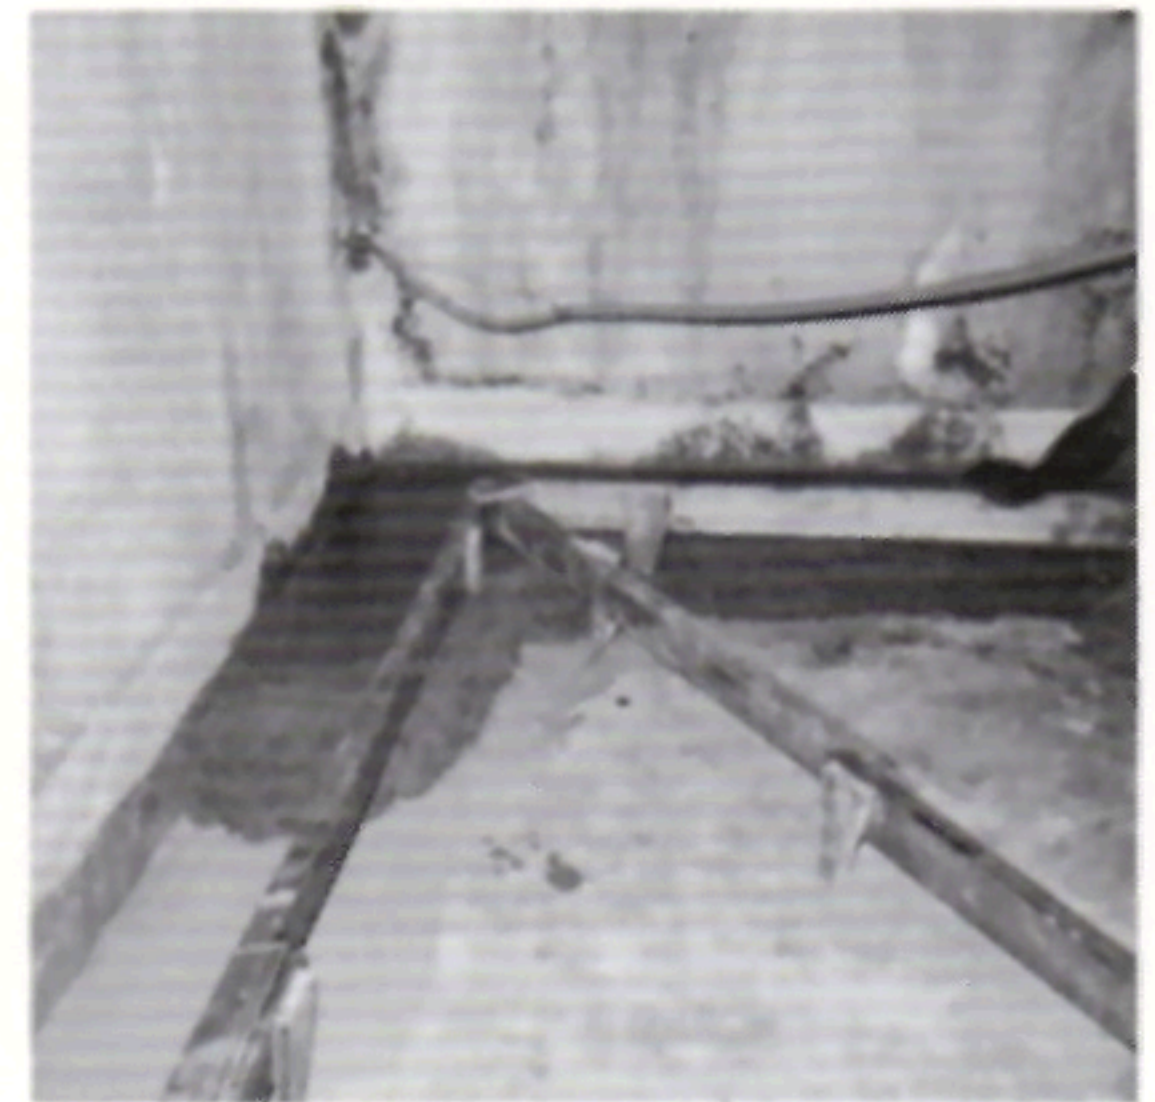
A detail of the vent shaft area, showing new concrete forms in place.

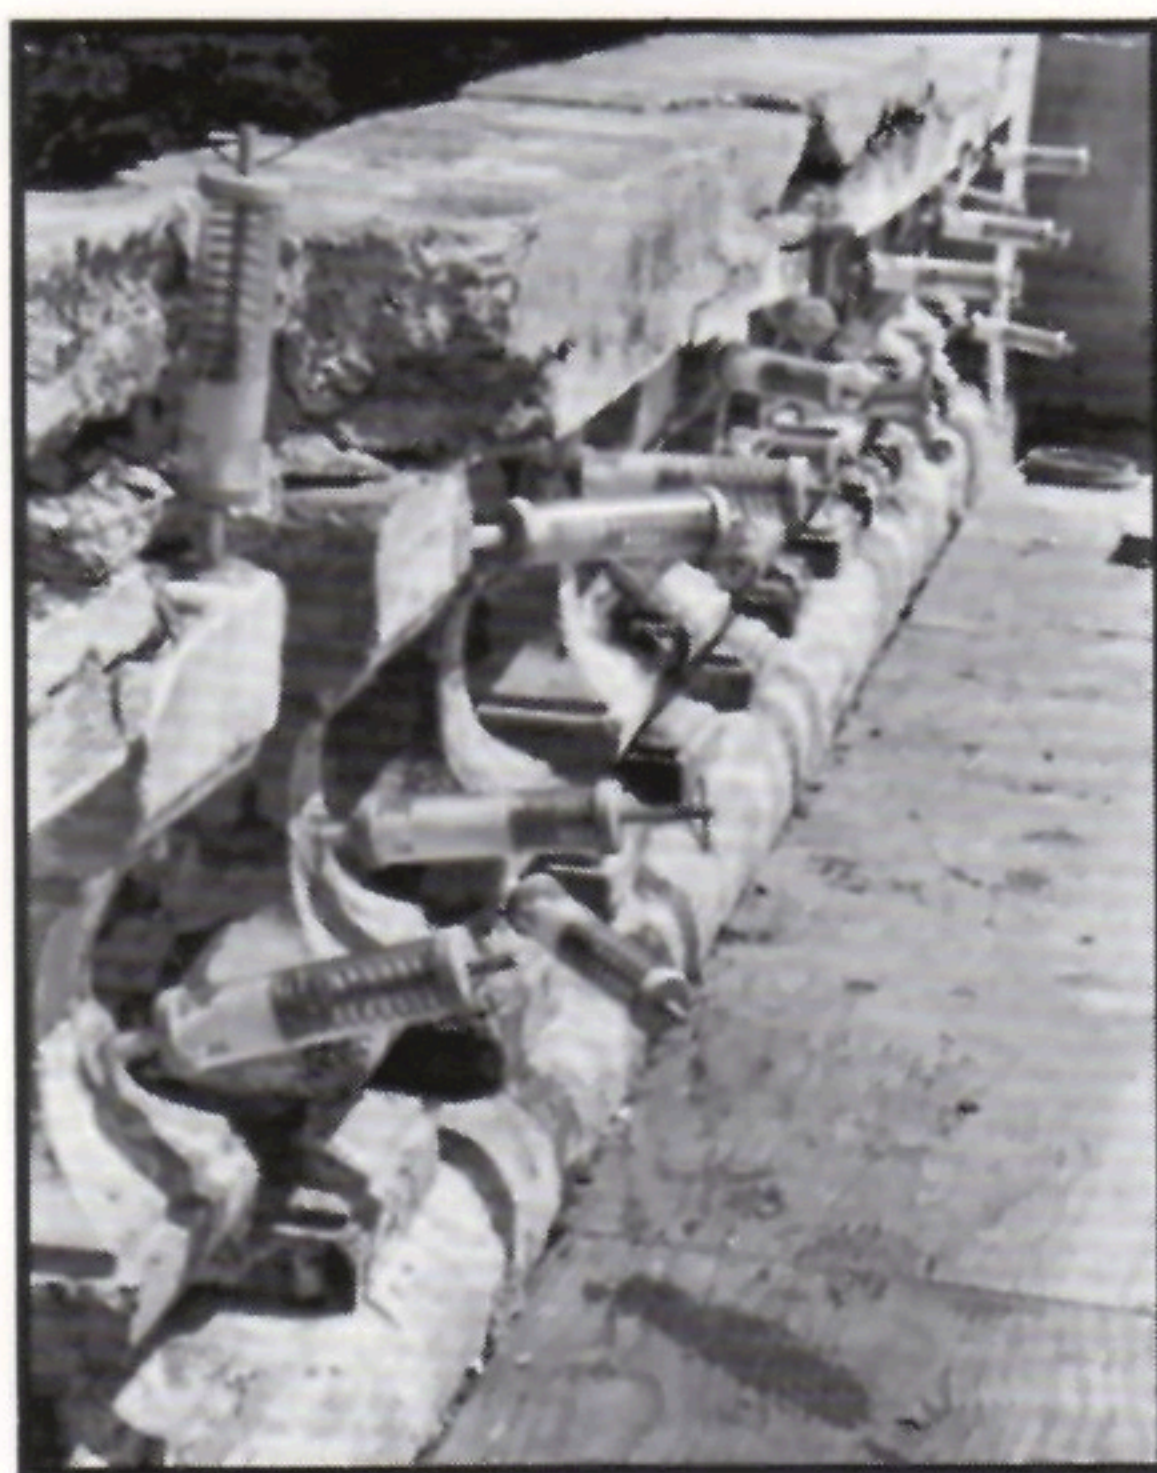
Deteriorated Balustrade

The concrete balustrade of this historic building was in varying stages of failure - complete failure to partial deterioration. The client desired to salvage as much of the 80 year old structure as possible. Just because your deteriorated railing may not be at the top of a 80 year old structure listed on the historic register does not mean you should wait to repair it.

A low pressure epoxy injection system was used in all cracks to prevent further crumbling of the concrete pickets and railing. Spalled concrete was chipped away and replaced with Thorite over a coating of ProBond 200.
